**Appendix 8.2 Millennium East Wind Farm  
Peat Depth Survey Report**

### Peat Depth Survey Report

April 2025

Prepared by : Fluid Environmental Consulting Ltd

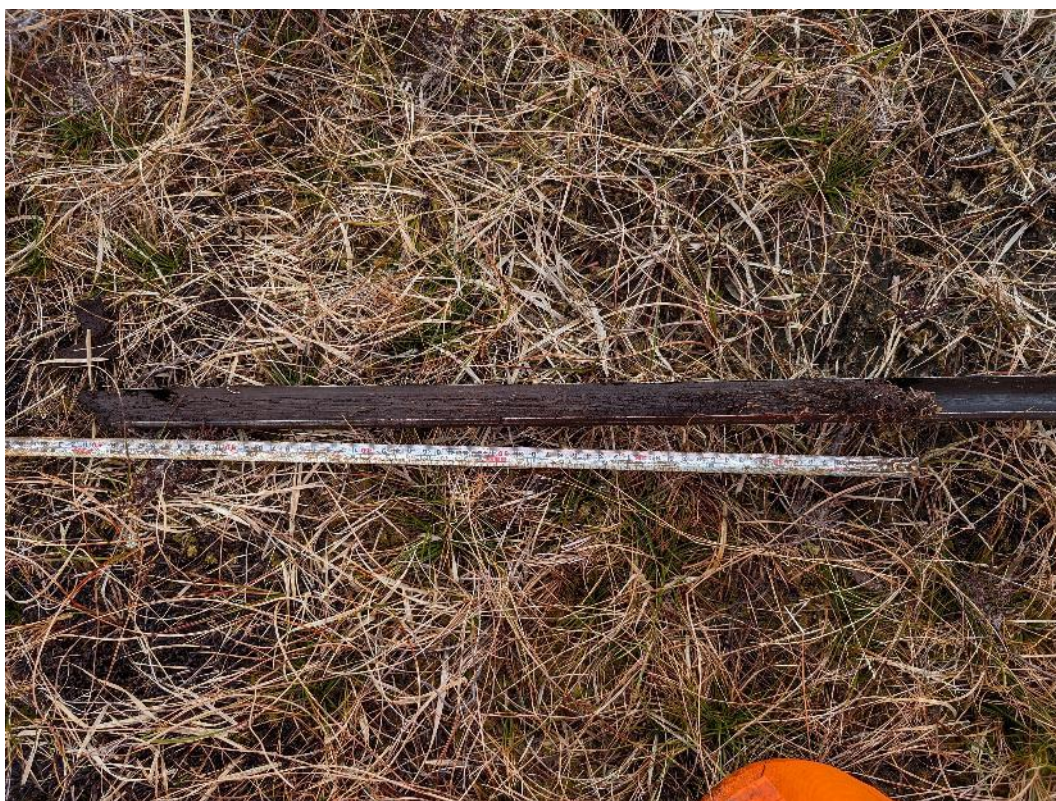
Photo 1 Example of a peat core showing a distinct layers of acrotelm and catotelm.

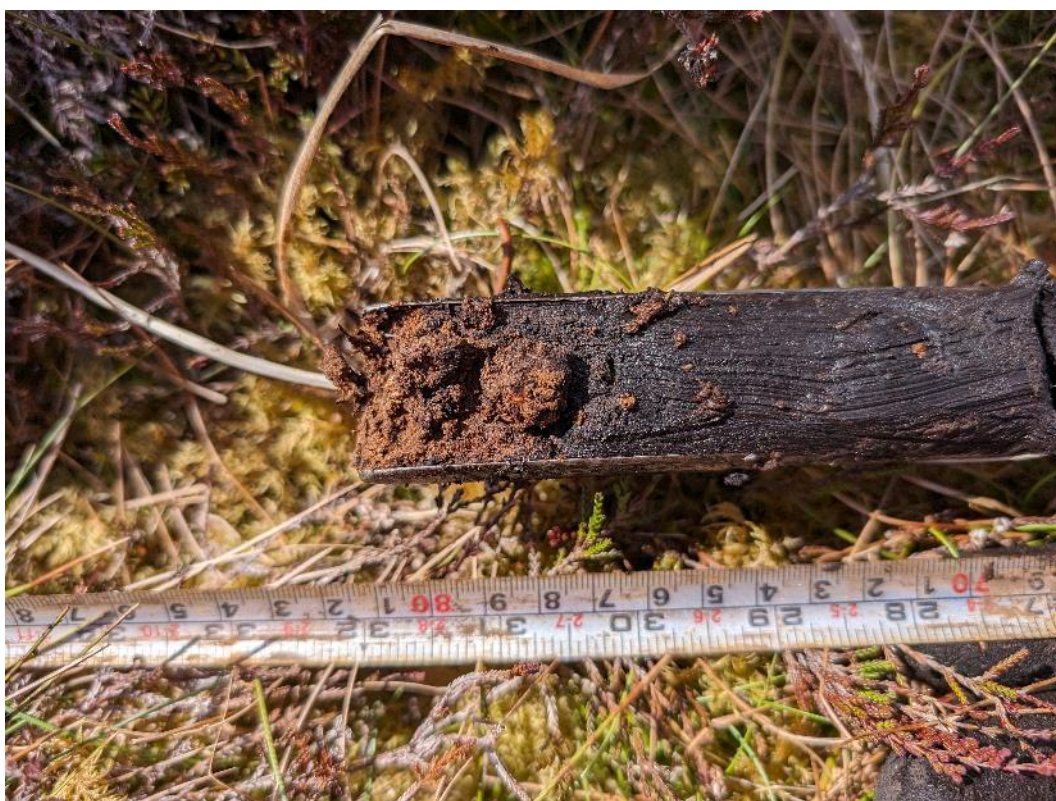
Photo 2 Example of a layer of silt in a core.

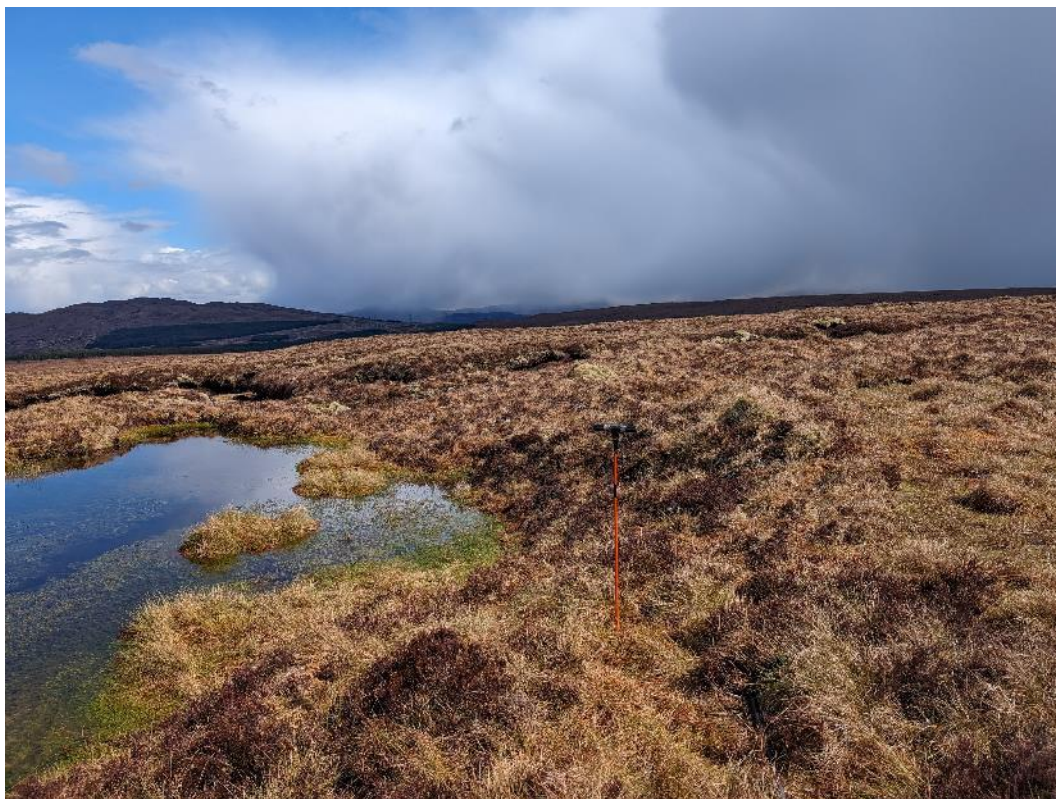
Photo 3 Example of ground conditions on site.

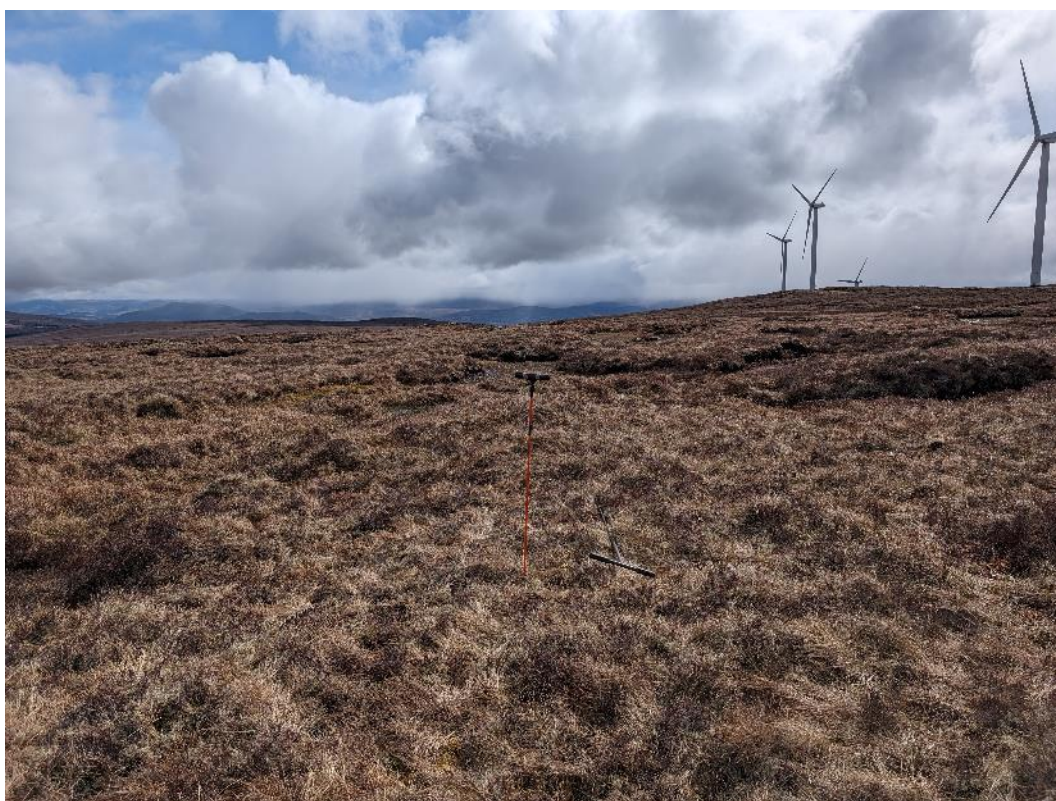
Photo 4 Example of ground conditions on site.

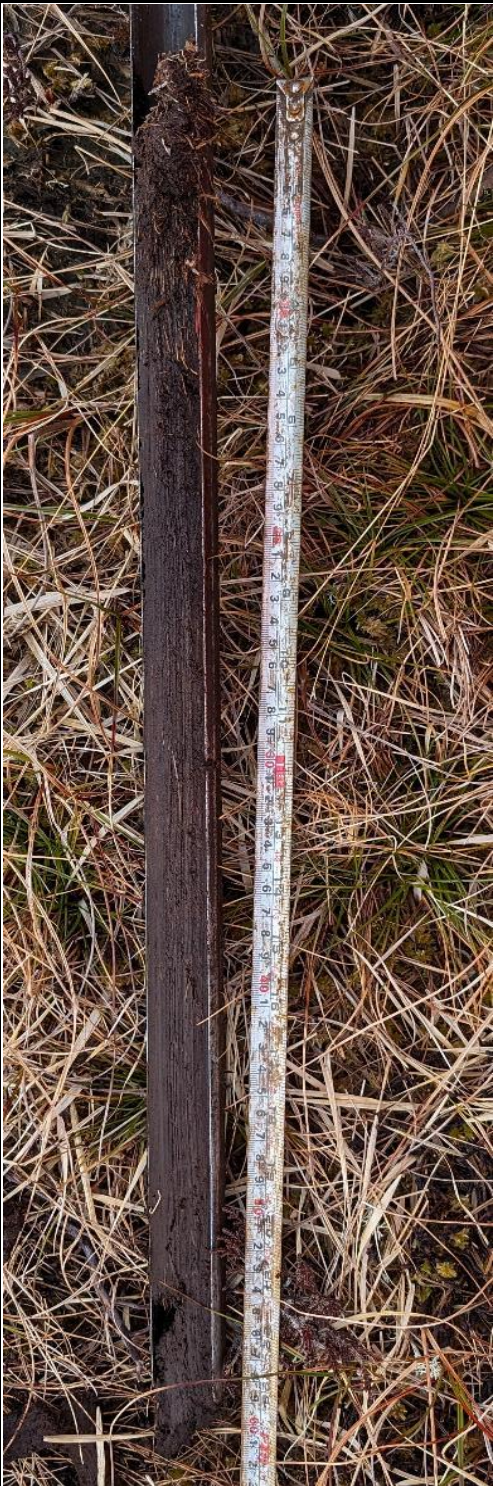
| Site: | Millennium East Wind Farm | | | | Client: | RSK Environment Ltd | | | | |
|---|---|---|---|---|---|---|---|---|---|---|
| Notes: | Open moorland, gentle slope, some peat erosion | | | | | | | | | |

| 0-0.6m | Formation |
|---|---|
| | Acrotelm |
| | Catotelm |
| | Rock at 0.60m |

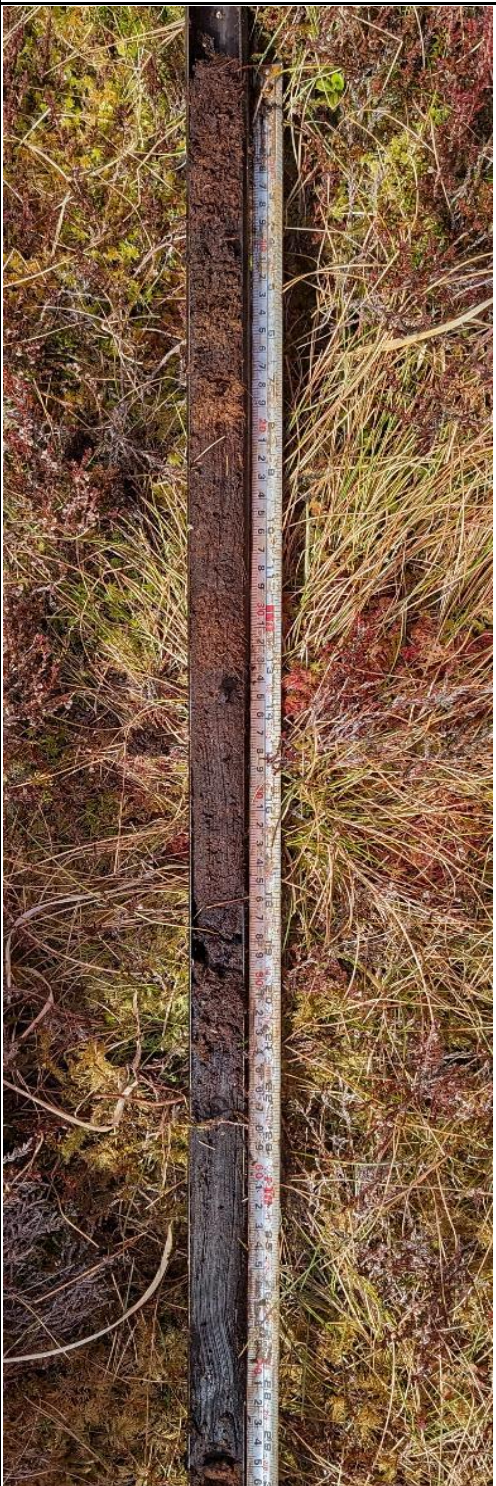
| Site: | Millennium East Wind Farm | | | | Client: | RSK Environment Ltd | | | | |
|---|---|---|---|---|---|---|---|---|---|---|
| Notes: | Open moorland, moderate slope | | | | | | | | | |

| 0-0.8m | Formation |
|---|---|
| | Acrotelm |
| | Catotelm |
| | Silt at 0.75m |

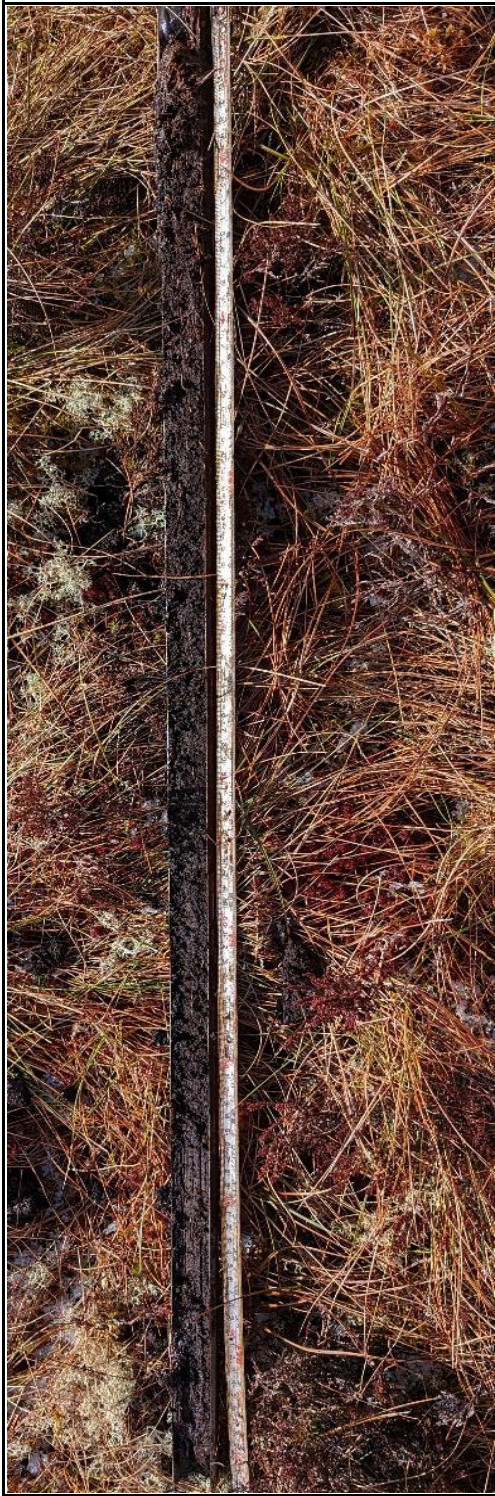
| Notes: | | Open moorland, gentle slope, close to a sphagnum pool | | | | | | | | |

| 0-1.0m | Formation |
|---|---|
| | <p>Acrotelm</p> <p>Catotelm</p> <p>Rock at 1.00m</p> |

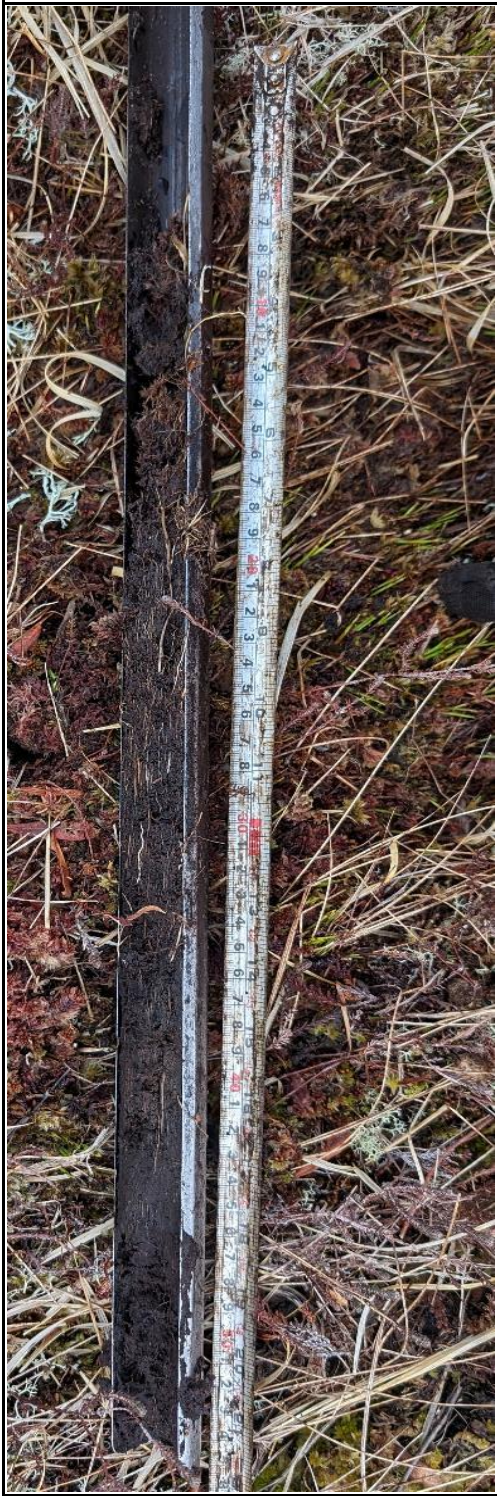
| Notes: | | Open moorland, rocky outcrops, moderate slope | | | | | | | | |

| | Acrotelm |
| | Catotelm |
| | Rock at 0.55m |

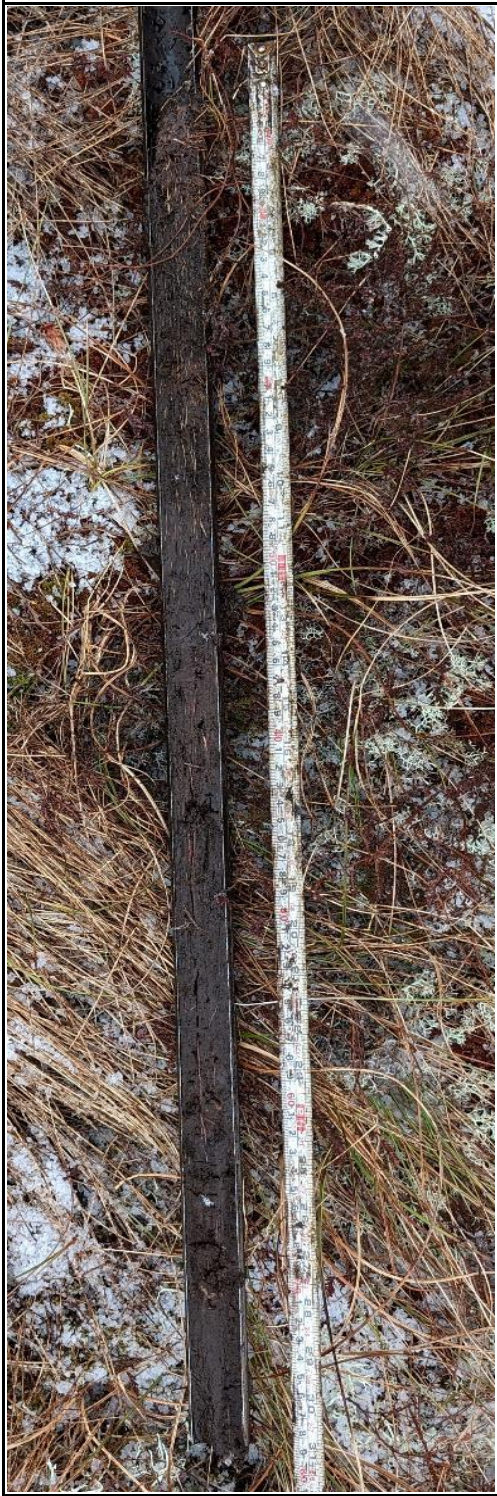
| Notes: | | Open moorland, gentle slope | | | | | | | | |

| 0-0.8m | Formation |
|---|---|
| | Acrotelm |
| | Catotelm |
| | Rock at 0.80m |

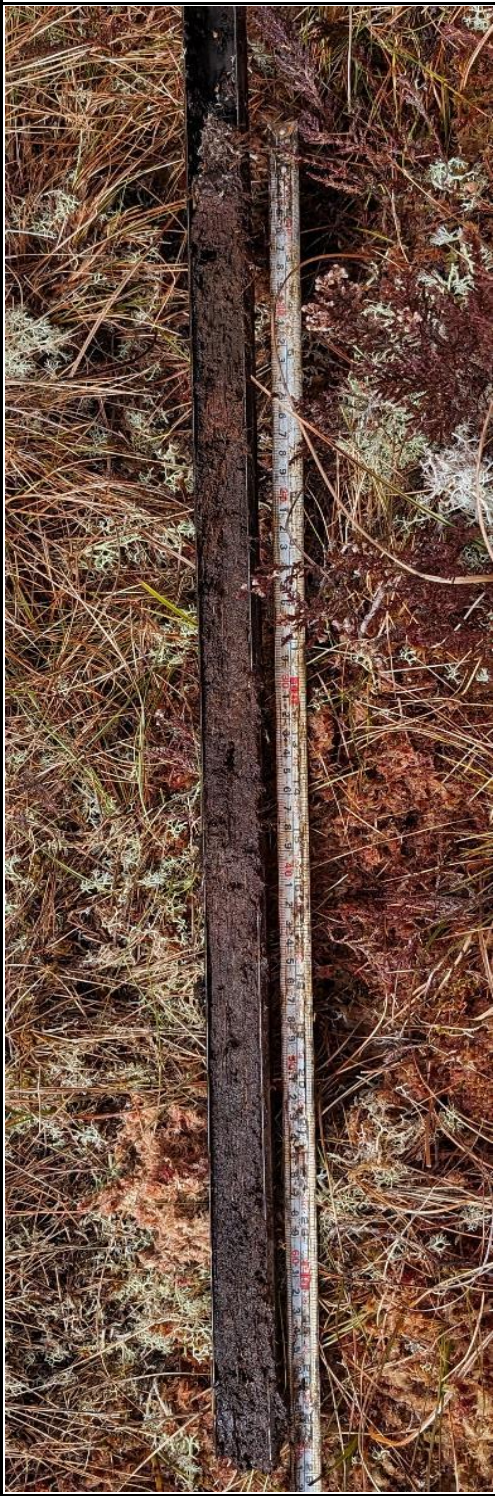
| Notes: | | Open moorland, gentle slope, close to a sphagnum pool | | | | | | | | |

| 0-0.7m | Formation |
|---|---|
| | Acrotelm |
| | Catotelm |
| | Rock at 0.70m |

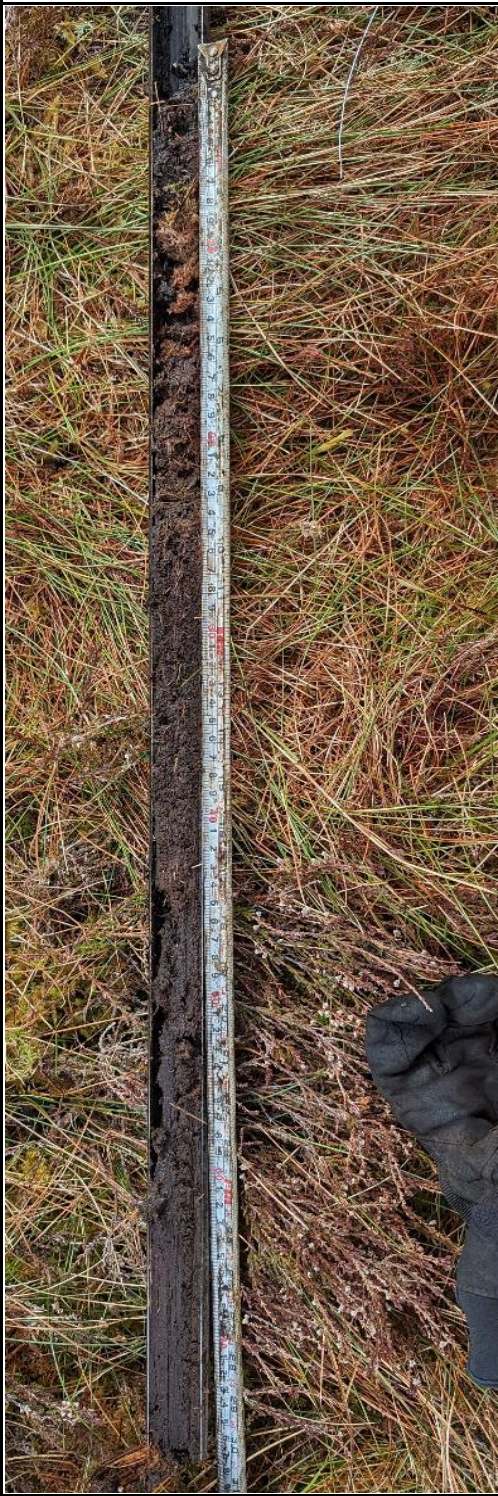
| Notes: | | Open moorland, gentle slope | | | | | | | | |

| 0-0.75m | Formation |
|---|---|
| | Acrotelm |
| | Catotelm |
| | Rock at 0.75m |

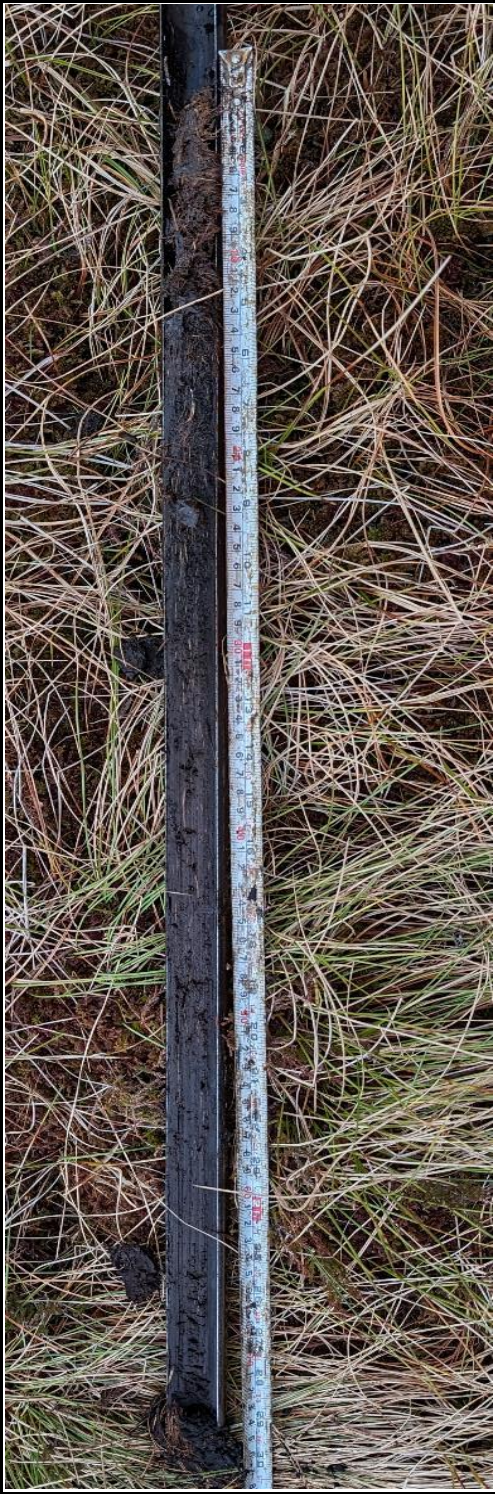
| Notes: | | Open moorland, moderate slope | | | | | | | | |

| | Acrotelm |
| | Catotelm |
| | Rock at 0.80m |

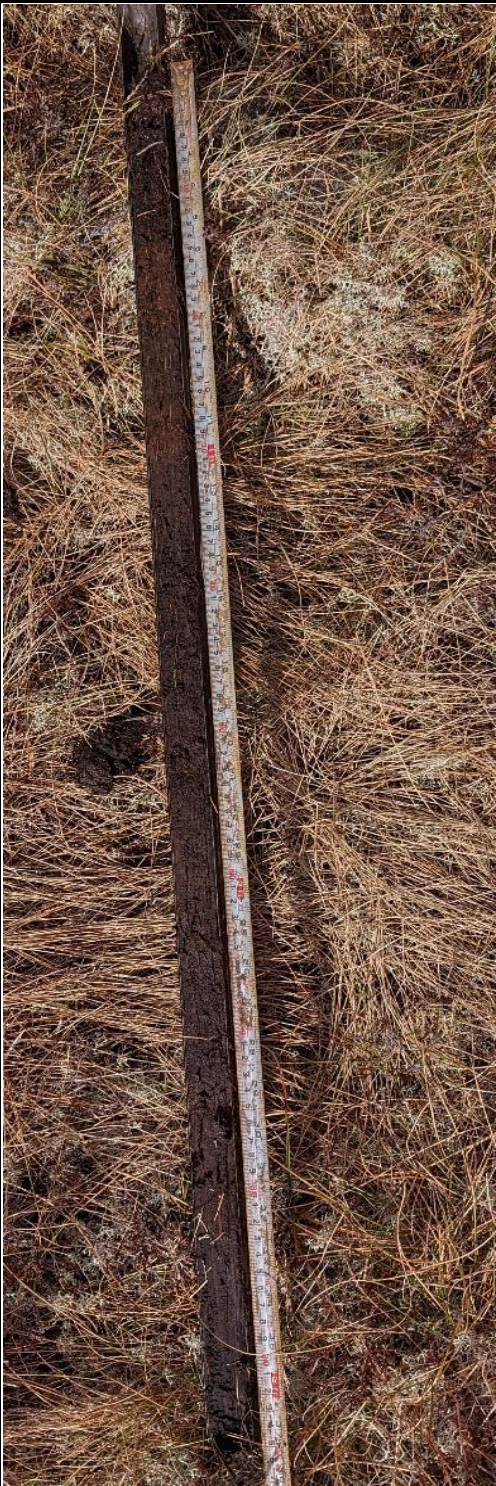
| Site: | Millennium East Wind Farm | | | | Client: | RSK Environment Ltd | | | | |
|---|---|---|---|---|---|---|---|---|---|---|
| Notes: | Open moorland, gentle slope, some peat erosion | | | | | | | | | |

| 0-0.95m | Formation |
|---|---|
| | Acrotelm |
| | Catotelm |
| | Rock at 0.95m |

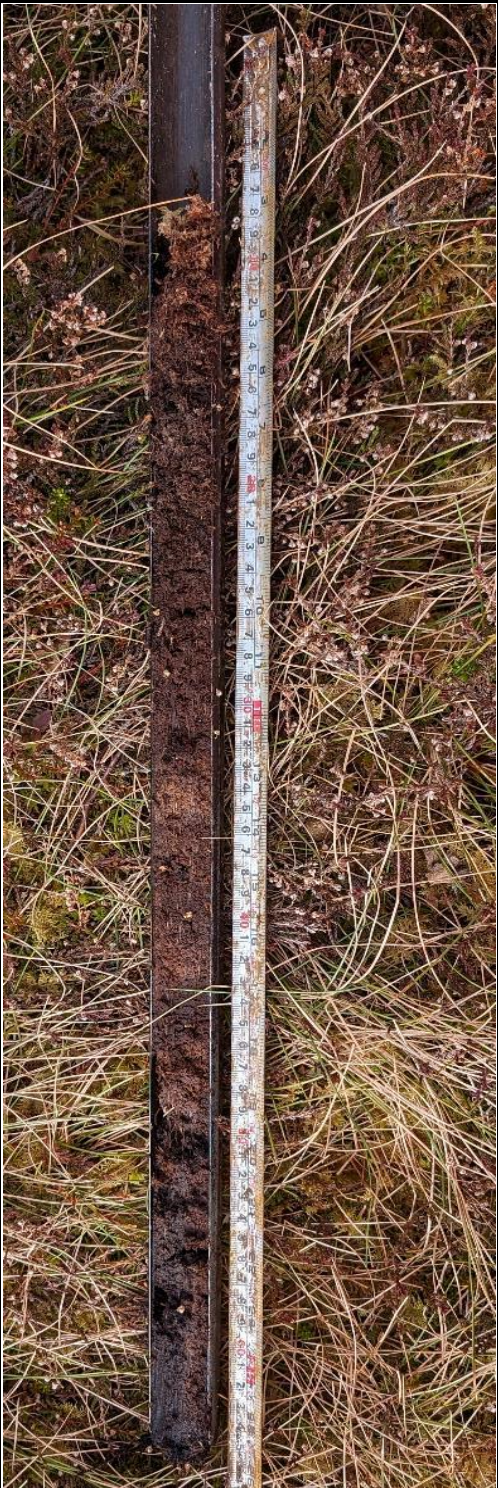
| Site: | Millennium East Wind Farm | | | | Client: | RSK Environment Ltd | | | | |
|---|---|---|---|---|---|---|---|---|---|---|
| Notes: | Open moorland, gentle slope, rocky outcrops, side of a shallow valley | | | | | | | | | |

| 0-0.65m | Formation |
|---|---|
| | Acrotelm |
| | Catotelm |
| | Rock at 0.65m |

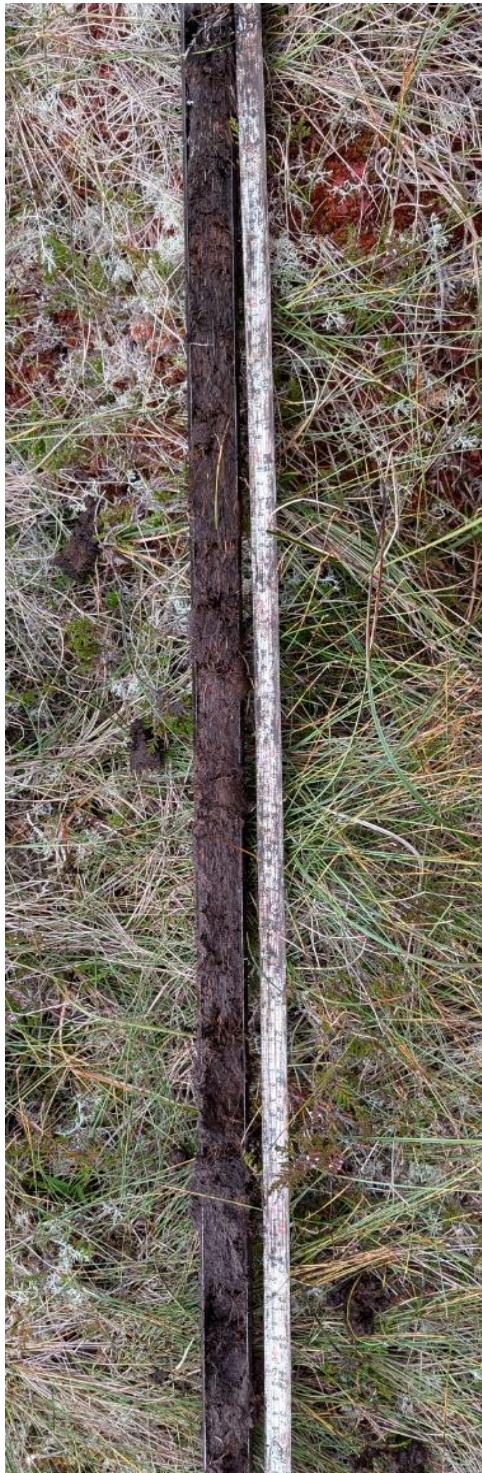
| Site: | Millennium East Wind Farm | | | | Client: | RSK Environment Ltd | | | | |
|---|---|---|---|---|---|---|---|---|---|---|
| Notes: | Open moorland, peat erosion nearby, Flat | | | | | | | | | |

| 0-1.0m | Formation |
|---|---|
| | Acrotelm |
| | Catotelm |
| | Rock at 1.00m |

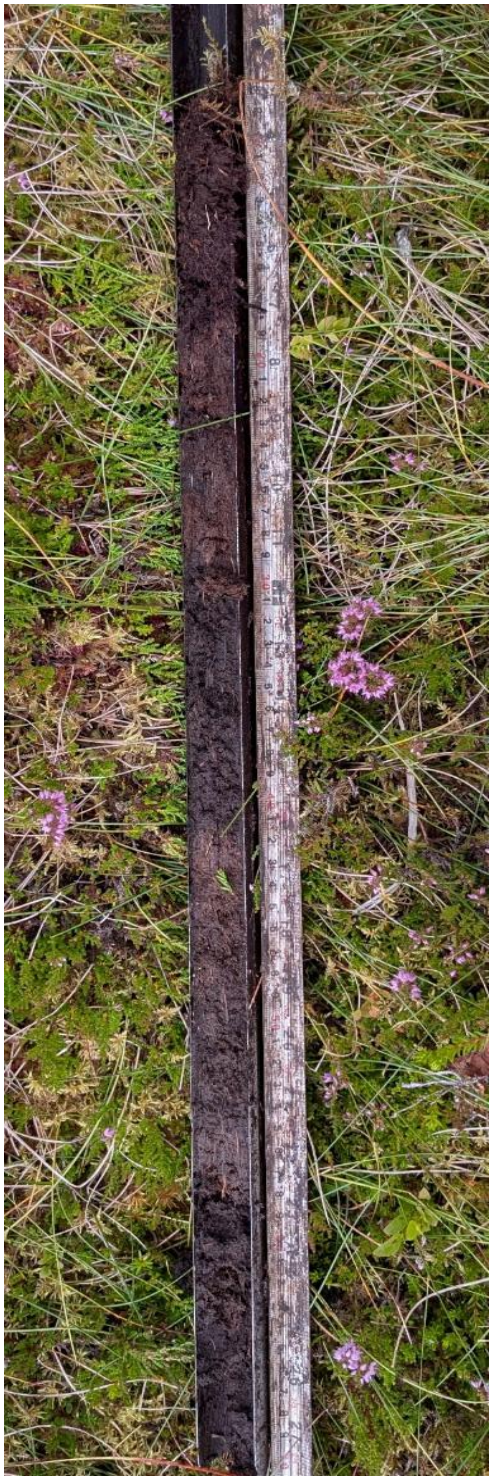
| Site: | Millennium East Wind Farm | | | | Client: | RSK Environment Ltd | | | | |
|---|---|---|---|---|---|---|---|---|---|---|
| Notes: | Open moorland, gentle slope. Top 0.05m liquid. | | | | | | | | | |

| 0-0.70m | Formation |
|---|---|
| | Acrotelm |
| | Catotelm |
| | Rock at 0.70m |

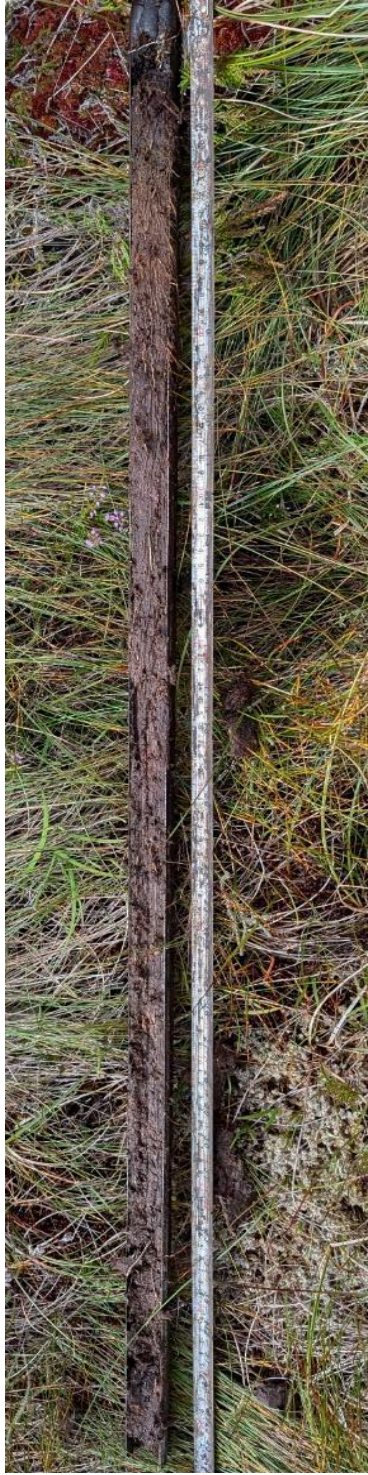
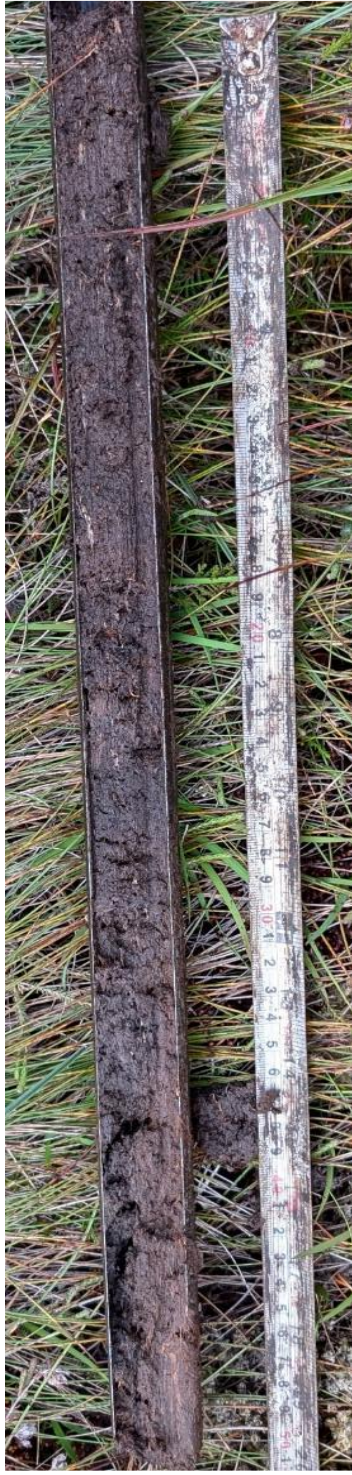
| <b>Notes:</b> | Open moorland, gentle slope | | | | | | | | | |

| 0-1m | Formation | 1-1.50m | Formation |
| | Acrotelm | | Catotelm |
| | Catotelm | | Rock at 1.50m |

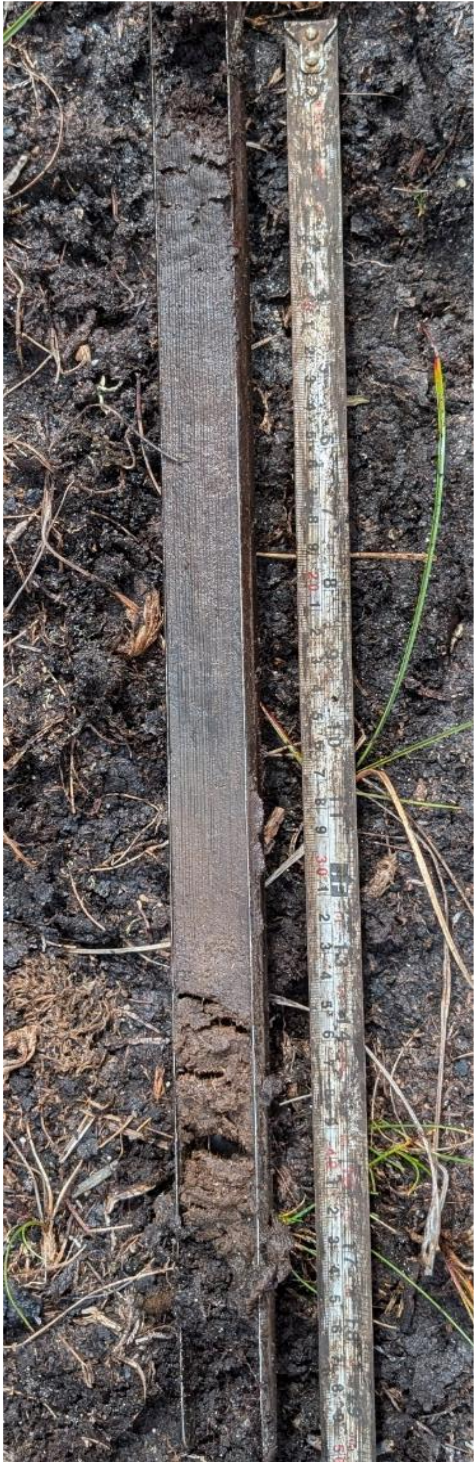
| Notes: | | Open moorland, core taken within area of peat erosion, gentle slope | | | | | | | | |

| 0-0.50m | Formation |
|---|---|
| | <p>Catotelm</p> <p>Rock at 0.50m</p> |

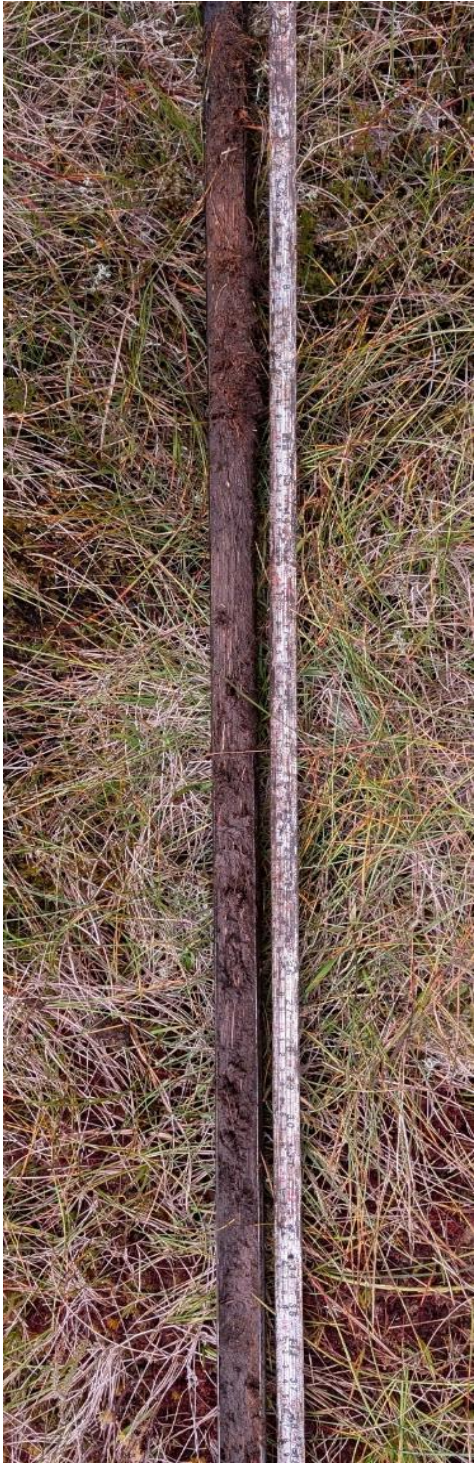
| Notes: | | Open moorland, moderate slope | | | | | | | | |

| 0-1.0m | Formation |
|---|---|
| | Acrotelm |
| | Catotelm |
| | Rock at 1.00m |

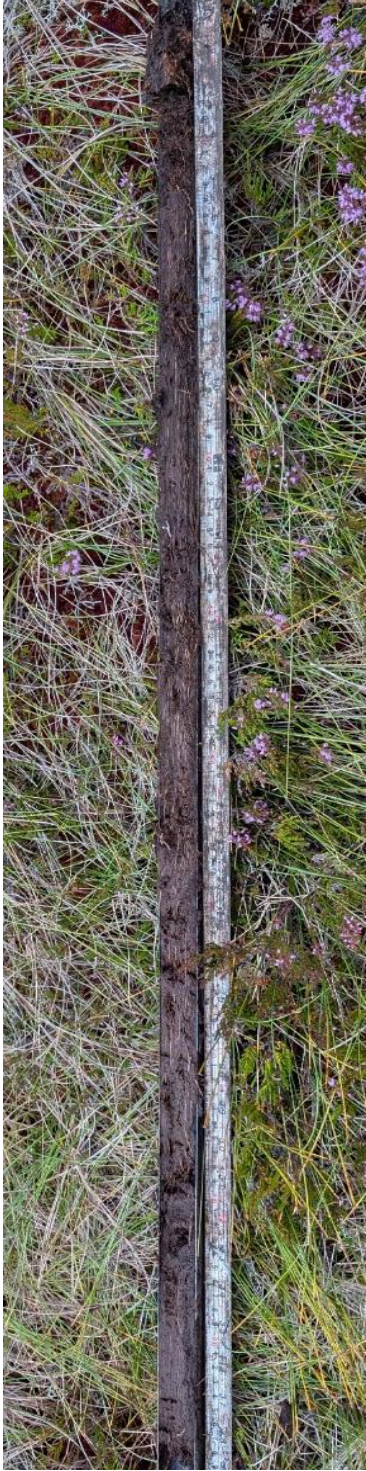
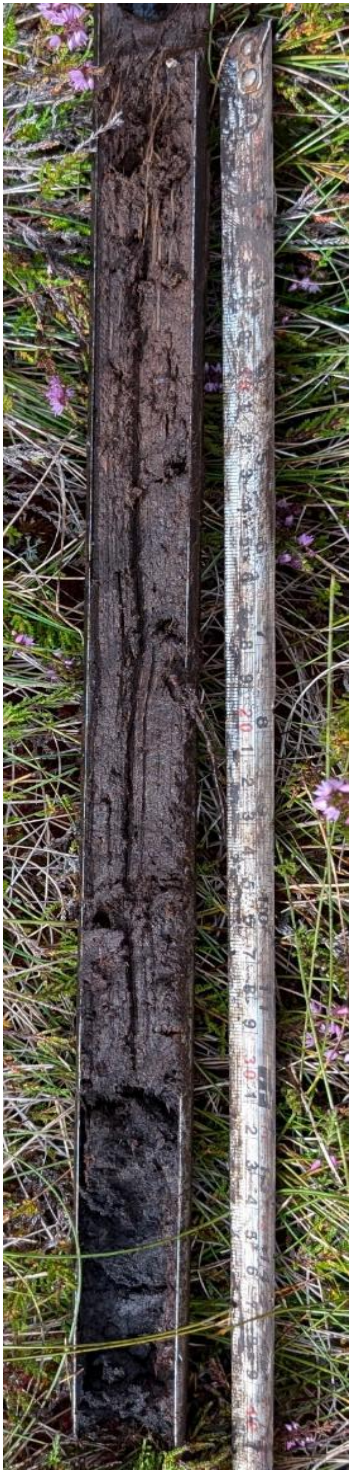
| <b>Notes:</b> | Open moorland, gentle slope | | | | | | | | | |

| 0-1m | Formation | 1-1.40m | Formation |
| | Acrotelm | | |
| | Catotelm | | Catotelm |
| | | | Rock at 1.40m |

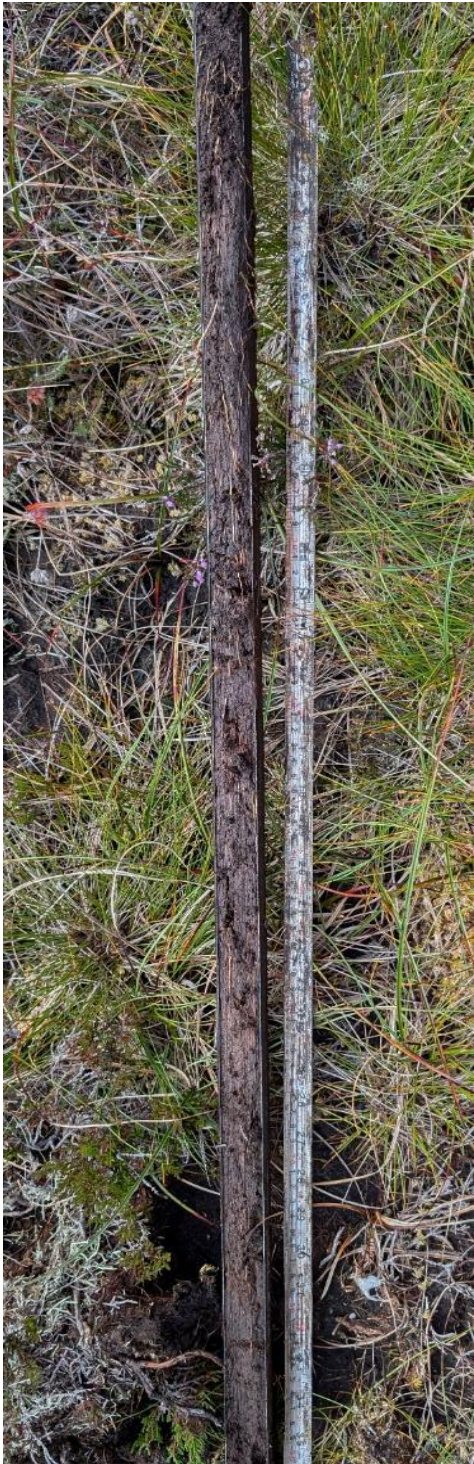
| Site: | Millennium East Wind Farm | | | | Client: | RSK Environment Ltd | | | | | |
|---|---|---|---|---|---|---|---|---|---|---|--|
| Notes: | Open moorland, gentle slope | | | | | | | | | | |

| 0-1.0m | Formation |
|---|---|
| | Acrotelm |
| | Catotelm |
| | Rock at 1.00m |

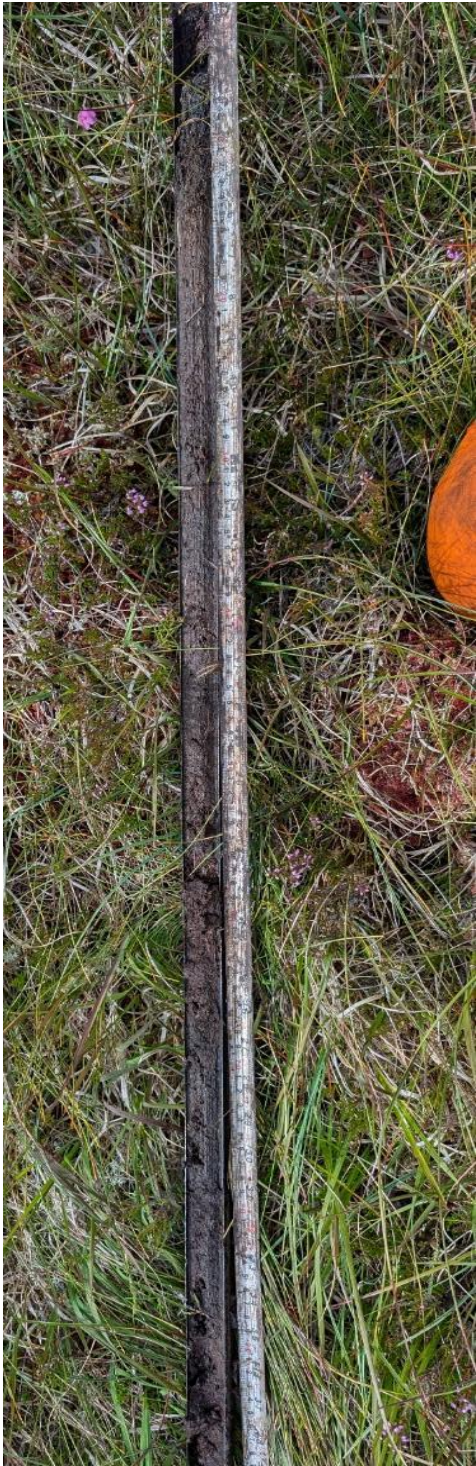
| Notes: | | Open moorland, gentle slope | | | | | | | | |

| 0-1.0m | Formation |
|---|---|
| | Acrotelm |
| | Catotelm |
| | Rock at 1.00m |

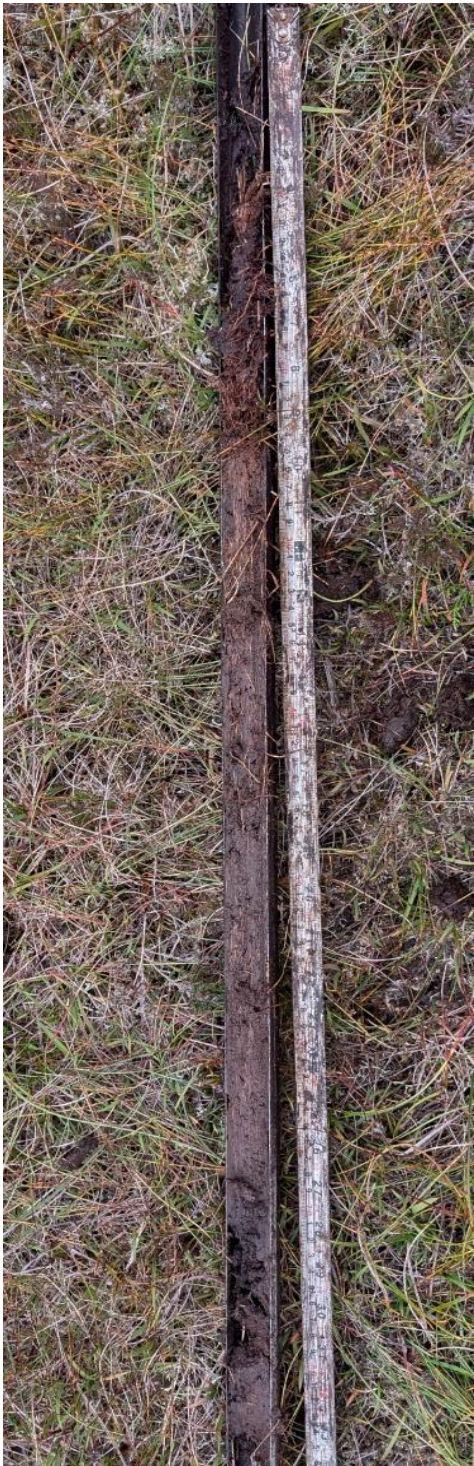
| Site: | Millennium East Wind Farm | | | | Client: | RSK Environment Ltd | | | | |
|---|---|---|---|---|---|---|---|---|---|---|
| Notes: | Open moorland, sphagnum pools nearby, gentle slope | | | | | | | | | |

| 0-0.90m | Formation |
|---|---|
| | Acrotelm |
| | Catotelm |
| | Rock at 0.90m |

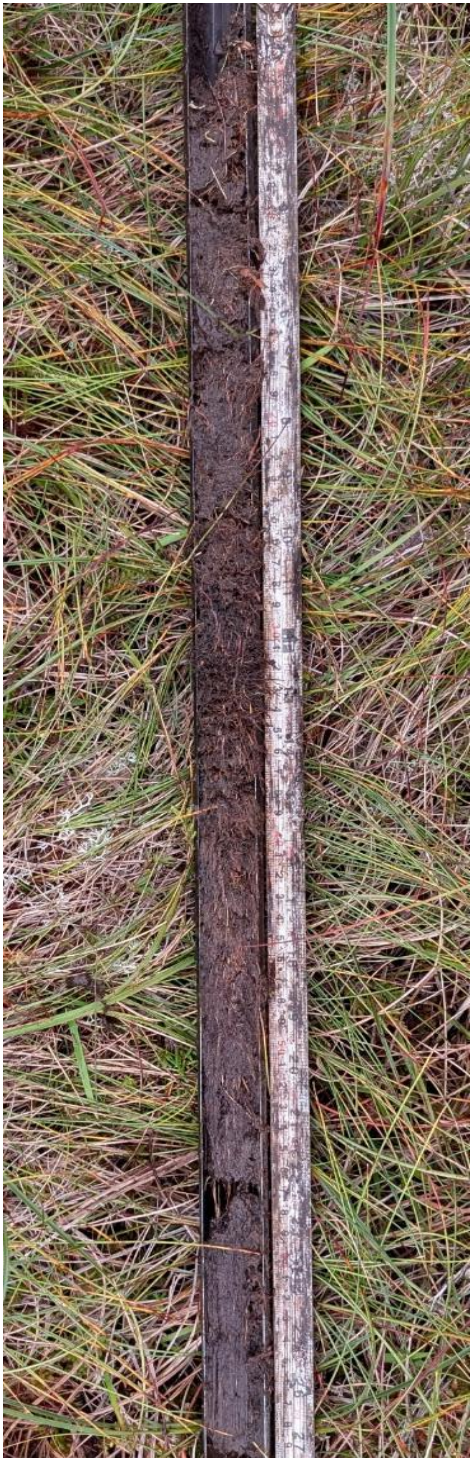
| Site: | Millennium East Wind Farm | | | | Client: | RSK Environment Ltd | | | | | |
|---|---|---|---|---|---|---|---|---|---|---|--|
| Notes: | Open moorland, gentle slope | | | | | | | | | | |

| 0-0.70m | Formation |
|---|---|
| | Acrotelm |
| | Catotelm |
| | Rock at 0.70m |

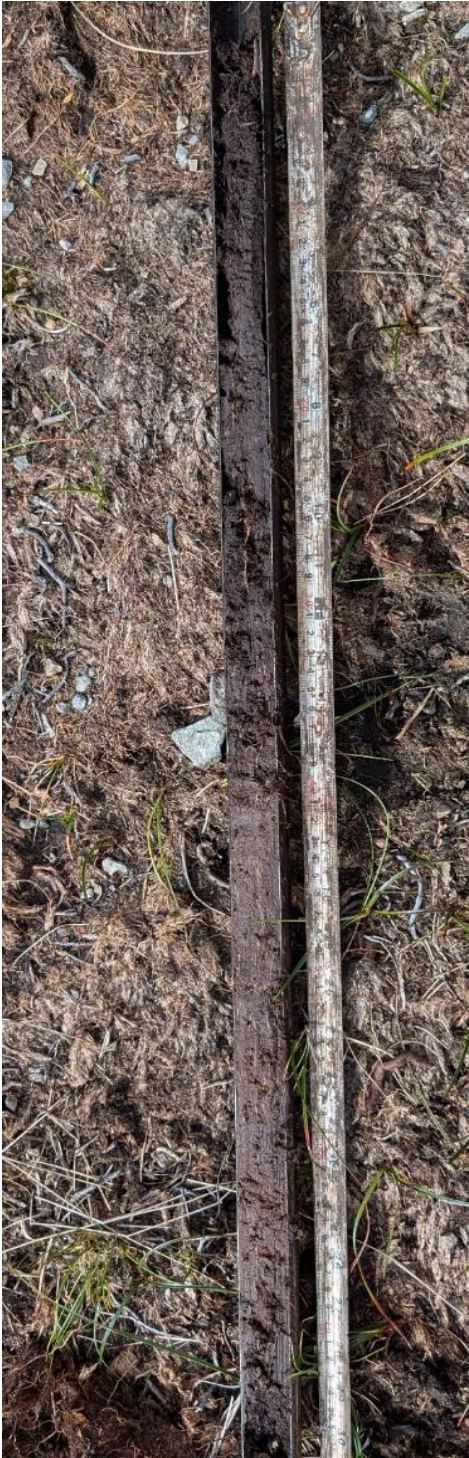
| Site: | Millennium East Wind Farm | | | | Client: | RSK Environment Ltd | | | | |
|---|---|---|---|---|---|---|---|---|---|---|
| Notes: | Open moorland, core taken within area of peat erosion, gentle slope | | | | | | | | | |

| 0-0.80m | Formation |
|---|---|
| | Catotelm |
| | Rock at 0.80m |

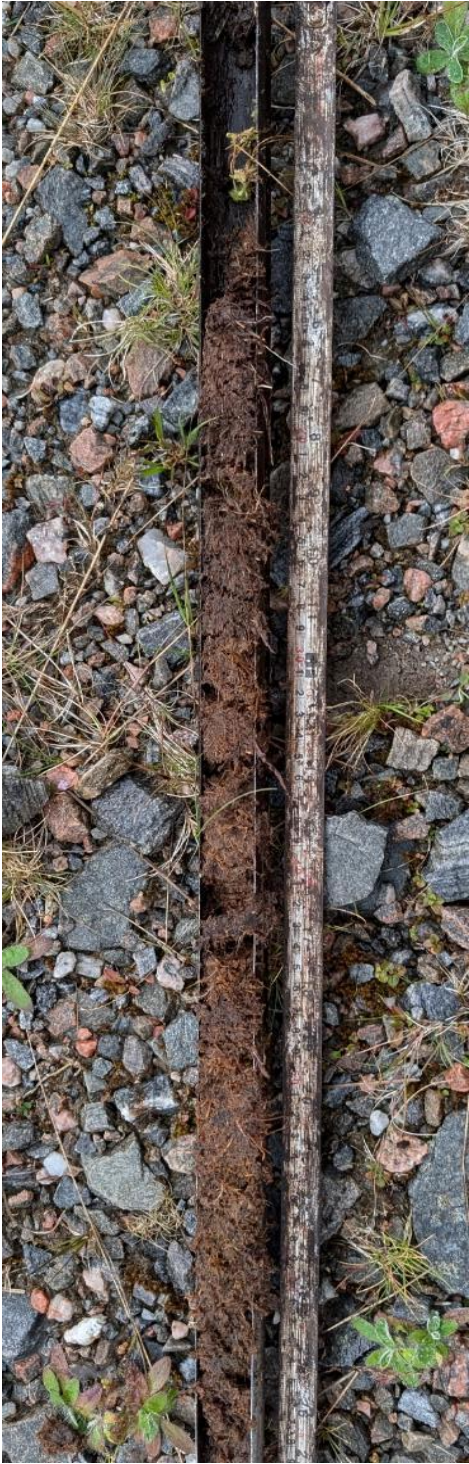
| Notes: | | Grassland with some small shrubs, fairly flat | | | | | | | | |

| 0-0.70m | Formation |
|---|---|
| | Acrotelm |
| | Catotelm |
| | Rock at 0.70m |

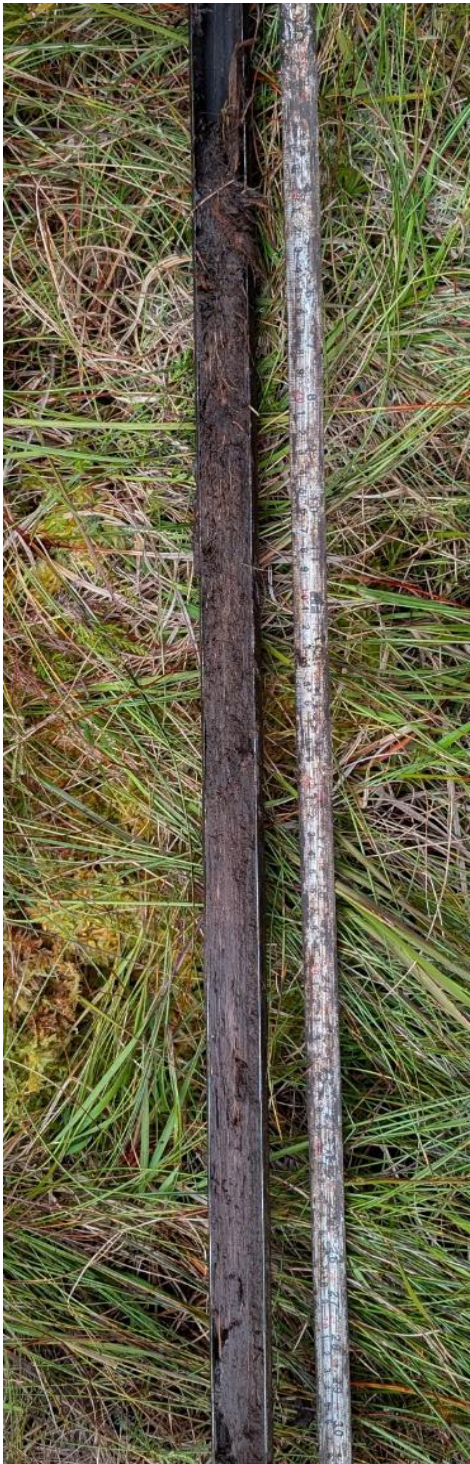
| Site: | Millennium East Wind Farm | | | | Client: | RSK Environment Ltd | | | | |
|---|---|---|---|---|---|---|---|---|---|---|
| Notes: | Open moorland, gentle slope | | | | | | | | | |

| 0-0.75m | Formation |
|---|---|
| | Acrotelm |
| | Catotelm |
| | Rock at 0.75m |

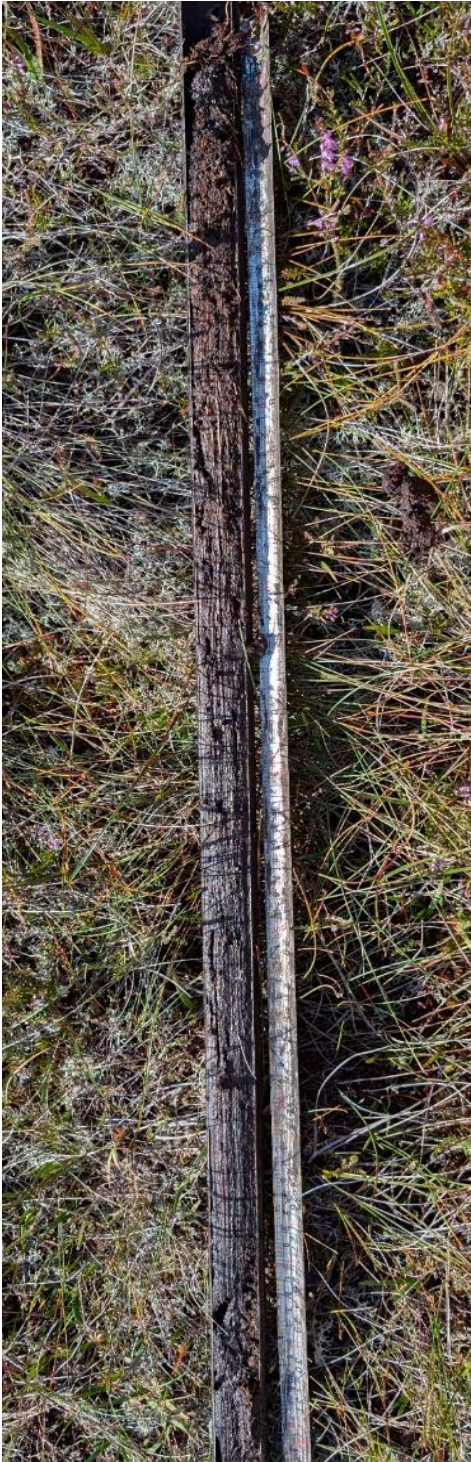
| Site: | Millennium East Wind Farm | | | | Client: | RSK Environment Ltd | | | | | |
|---|---|---|---|---|---|---|---|---|---|---|--|
| Notes: | Open moorland, gentle slope | | | | | | | | | | |

| 0-0.85m | Formation |
|---|---|
| | Acrotelm |
| | Catotelm |
| | Rock at 0.85m |
