**Appendix 8.2 Millennium East Wind Farm  
Peat Depth Survey Report**

### Peat Depth Survey Report

April 2025

Prepared by : Fluid Environmental Consulting Ltd

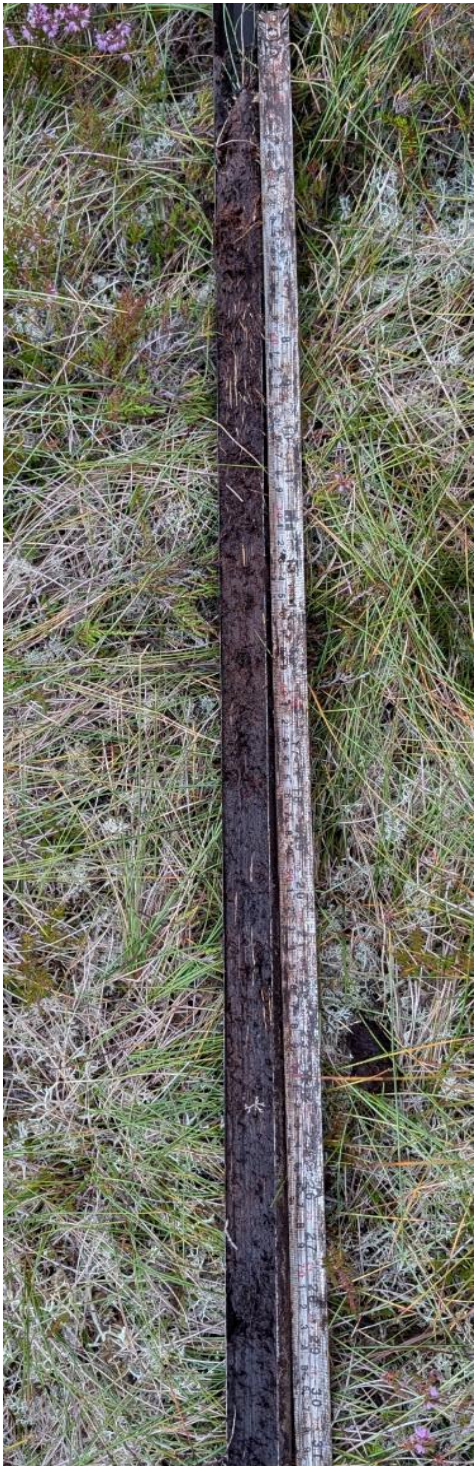
| Site: | Millennium East Wind Farm | | | | Client: | RSK Environment Ltd | | | | |
|---|---|---|---|---|---|---|---|---|---|---|
| Notes: | Open moorland, moderate slope | | | | | | | | | |

| 0-0.80m | Formation |
|---|---|
| | Acrotelm |
| | Catotelm |
| | Rock at 0.80m |
