Millennium East Wind Farm Technical Appendix 8.6 - Borrow Pit Assessment

Client : Nadara Limited

Document No. : OWC-043649-004-REP001

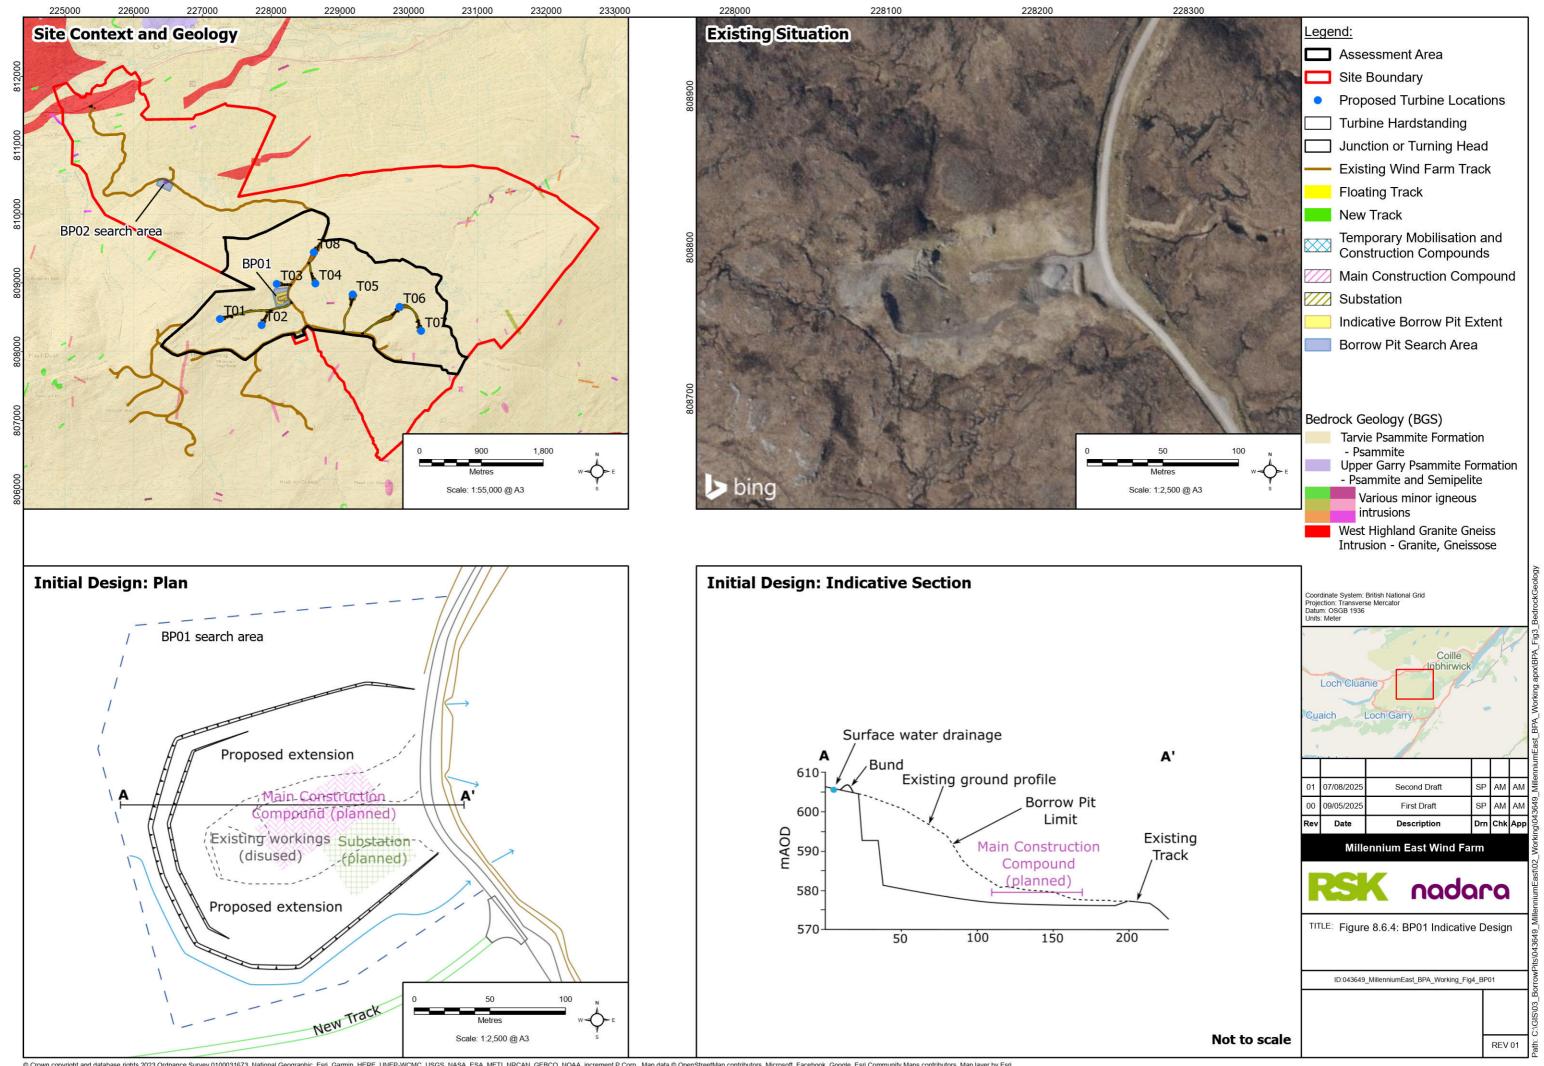
Figure 8.6.4 BP01 Indicative Design

Table 5-2 presents the proposed dimensions and estimated extraction volumes for BP01. Figure 8.6.4 shows the proposed borrow pit indicative design in plan and section view. The volumes given have been calculated from a simplified cut/fill calculation, considering the existing topography, borrow pit footprint dimensions, and indicative face dimensions (including benches).

The provided borrow pit dimensions and volumes are estimates and are likely to vary. The indicative borrow pit design (see Figure 8.6.4) includes a location map showing the borrow pit within the Site, an extract from OS mapping at the borrow pit search area, a plan view layout showing the proposed borrow pit footprint, and a schematic cross-section. They are produced using available 5m cell size DTM data and are not to be used in place of detailed designs.

Borrow Pit ID	Approx. working area footprint [m²]	Max. depth [m]	Approx. volume [m³]	Assumed overburden thickness [m]	Suggested extraction methods
BP 01	26,286 Incl. existing pit	22	177,814	0.5 m	Blasting, hammer, ripping, digging
(assi	action volume emoved) [m³]:	80,110
